ANALYTICAL METHODS FOR THE CONSERVATION OF THE BUDDHIST TEMPLE II OF KRASNAYA RECHKA, KYRGYZSTAN

Enrico Fodde

The methods employed for selecting the repair material for the Buddhist temple II of Krasnaya Rechka, a site located in the upper Chuy Valley, Kyrgyzstan, are described. The temple is built of mud brick and was excavated during several campaigns between 1938 and 1998 with no provision being made for conservation. The first emergency protective measures were initiated in 2003 during a UNESCO project that included other sites located in the Chuy valley. Most of the eroded walls of the temple were given a temporary shelter coat of mud bricks, a method that has proved effective. The main problem after proving the shelter coat was how to assess the repair material for future conservation work (it is planned to repeat the application of the shelter coat, but with materials with improved performance). Assessment was carried out after extensive laboratory analysis of both historic and repair materials, but also after test wall construction and monitoring. The methods explained here could be of use to conservators working in similar projects in the Middle East or Asia.

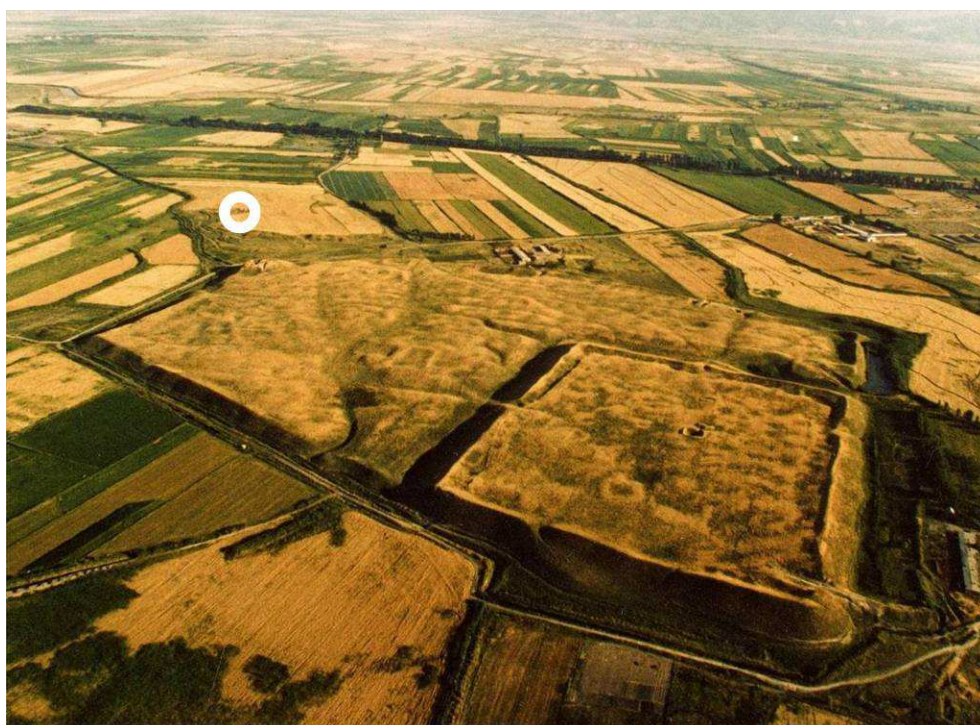
Fig 2. Aerial view of Krasnaya Rechka showing the two *shakhristan* (inner city) and the location of the Buddhist temple II (white circle). Picture kindly provided by Renato Sala

the first research there in 1938 [4]. The site is formed by two elevated inner cities (*shakhristan* 1 and 2) that include the administrative quarters (Fig. 2), whilst outside the city walls are the residential buildings and an area known as the necropolis. The cities of the Chuy valley were characterised by a cosmopolitan community and this is confirmed by the archaeological investigation that produced religious artifacts belonging not only to Buddhism but also to other religions such as Nestorian, Islamic, and Zoroastrian.

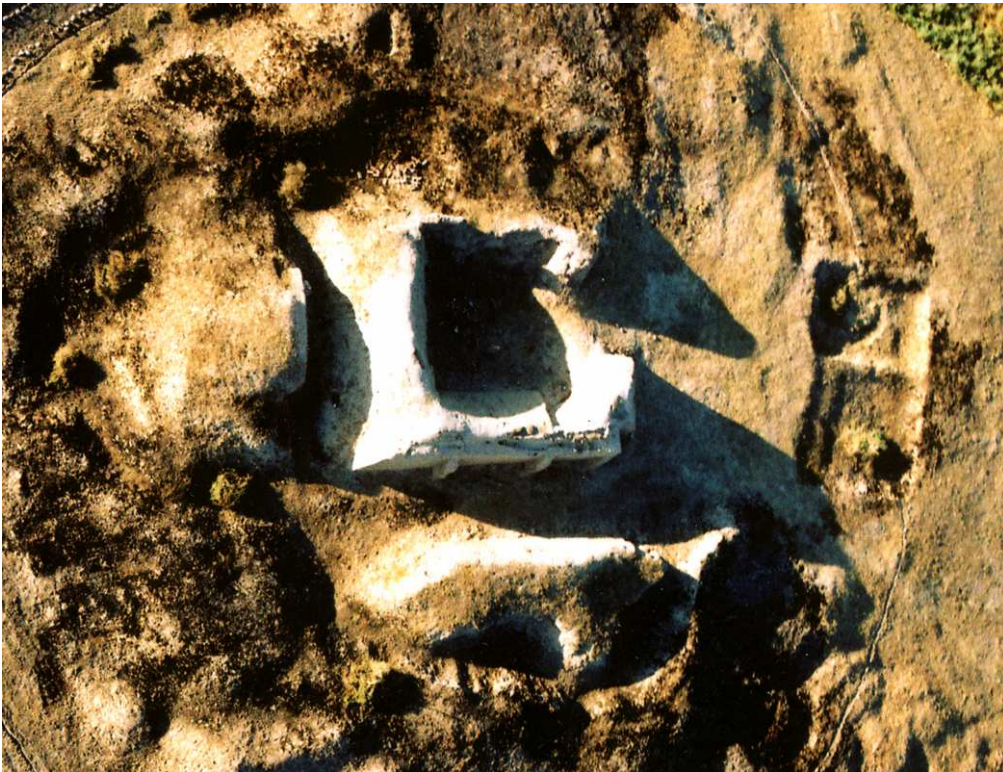
Fig. 3. Aerial picture of the Buddhist temple II (picture kindly provided by Renato Sala). Only the south and east corridor walls survive because extensive soil quarrying was carried out before 1938, date of the first archaeological excavation

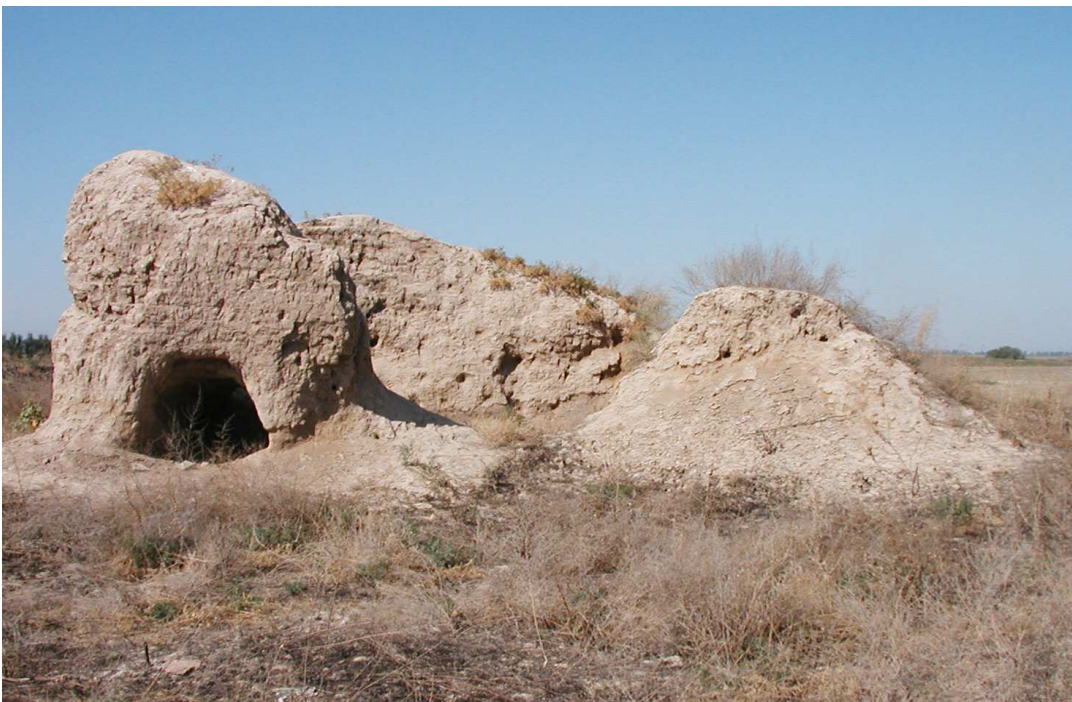
Fig. 4. The cella of the Buddhist temple II before conservation (2002). The arch on the left is the result of illegal quarrying. The site was found eroding at high speed due to rainy weather conditions in the area. Picture: Valery Kolchenko

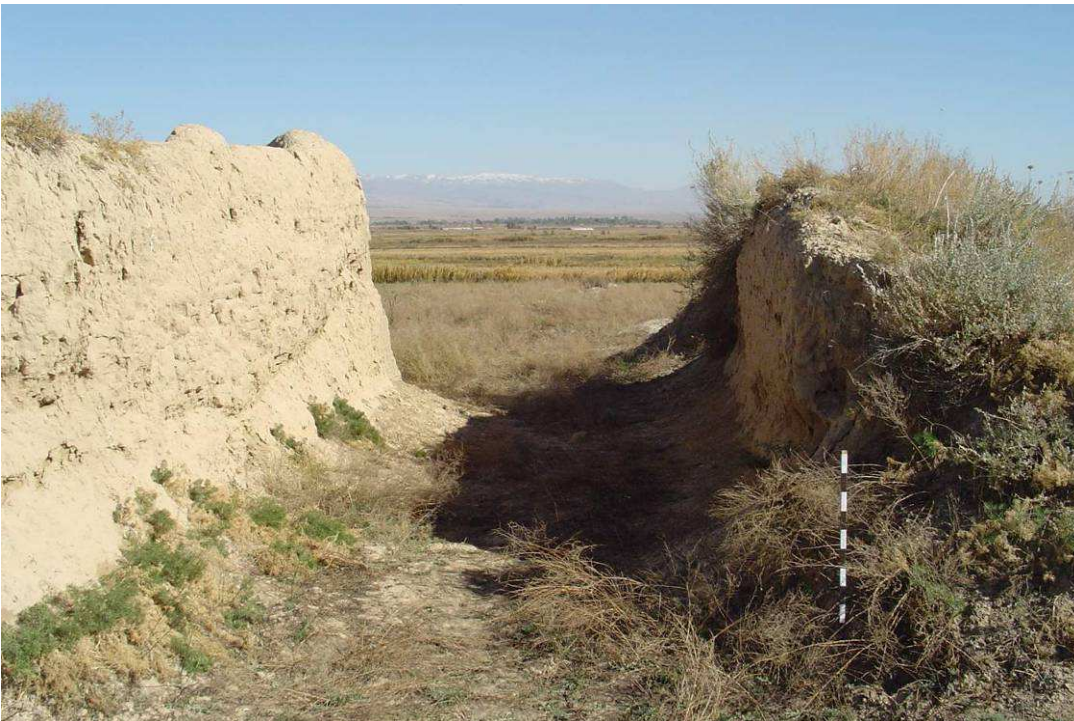
Fig. 6. Buddhist temple II, Krasnaya Rechka: the ambulatory passage before emergency shelter coating, 2002. Picture: John Hurd

The excavations revealed also that the corridor and cella were characterised by a mud floor. The temple was built with mud brick, and the walls (originally from 2 to 3 metres in thickness) were coated with a mud plaster of 5mm thickness. The excavation of the southern corridor revealed several fragments of wall paintings depicting the life of the Buddha. The predominant colours used in the paintings were blue and black; other pigments were yellow-orange, red-crimson, and green [11]. Wall paintings were applied over a 2-3mm coat made of gypsum. Another important constructional aspect is that the temple is built on a massive mud brick platform, a typical system adopted in several Central Asian sites, and that no trace of a stupa was found. The roofing method is not clear as archaeologists have contradictory views [12]. In September 2003 a temporary shelter coat was applied to the most endangered parts of the temple so as to protect the mud brick walls from further erosion (Figs. 6-9). The shelter coat was applied as follows [13]:

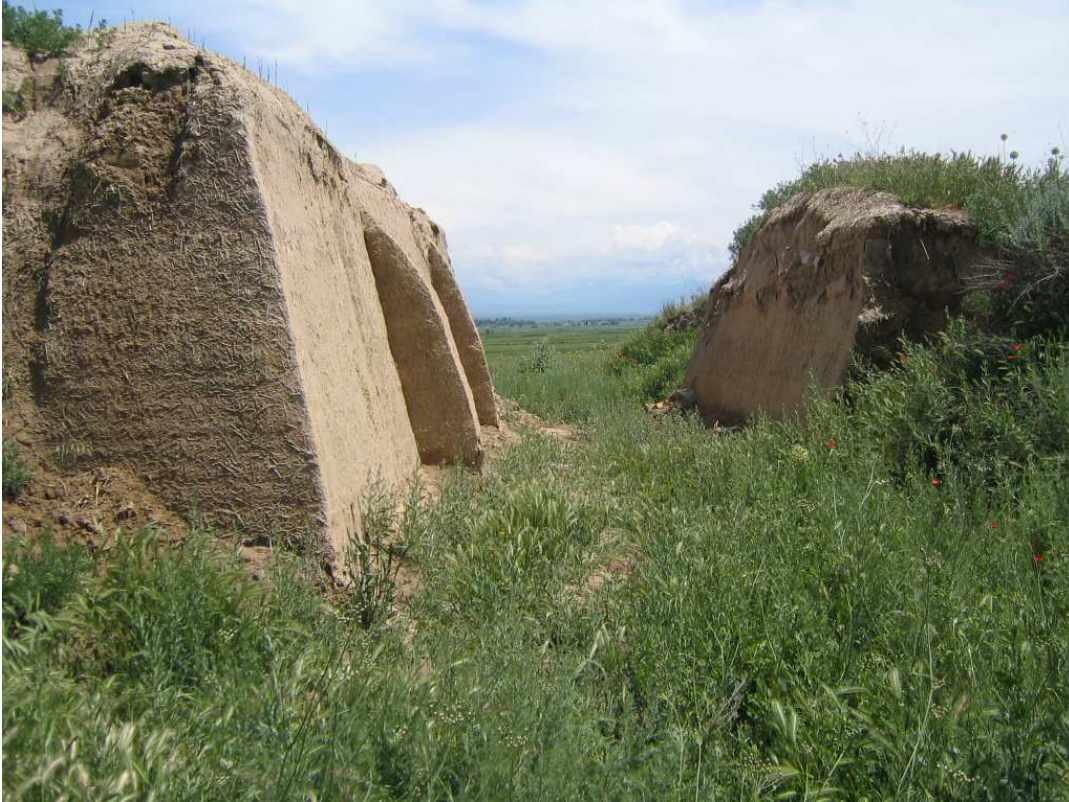
Fig. 7. Buddhist temple II, Krasnaya Rechka: the ambulatory passage after emergency shelter coating, May 2004. Shelter coating of wall on the right hand side is explained in Fig 9.

- geotextile (Dupont Tyvar Style SF 32) was employed as a separation layer between the historic structures and the shelter coat;
- construction of a mud brick shelter coat. The mud bricks employed for the construction of the encapsulation are clearly legible as a modern intervention. Mud brick buttresses were built in the south corridor;
- filling of gap between the geotextile and mud brick skin by employing dry sand;
- plastering of the mud brick shelter coat with a mix of soil and straw.

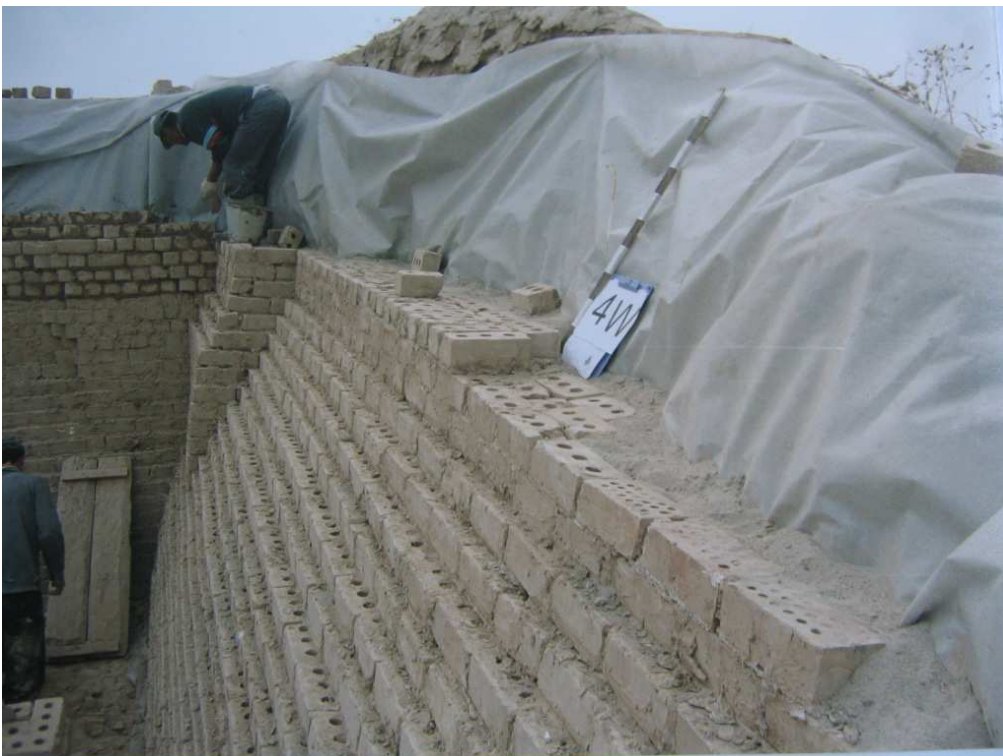
Fig. 8. Shelter coat construction showing mud bricks, sand infill, and geotextile (2003). Picture: Jumamadel Imankulov

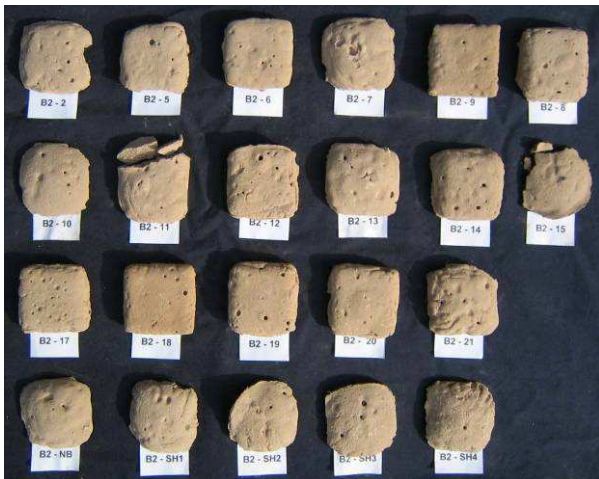
Fig. 18. Buddhist temple II. Wetting and drying after the 5th cycle

The scope of this test is the determination of the behaviour of soil prisms when subjected to wetting and drying cycles (Fig. 18). The experimental design is again a more aggressive simulation than the naturally-occurring causes of weathering of mud brick. In this respect the test is not a precise repetition of the field conditions of earthen buildings where the process occurs more slowly. Wetting and drying cycles have been recognised as an important factor in mud brick as well as in stone deterioration. The same mechanisms are at work in mud brick, but probably to a much greater extent. The results of the wetting and drying actions are most dramatic during drying conditions when the most significant amount of surface material becomes friable and falls from the walls at the slightest touch. The actual stresses resulting from wetting and drying cycles, as well as other internal forces, are certainly more obvious on the exposed surface of the mud brick material. For most practical purposes, when not in the presence of excessive moisture, the deterioration caused by such factors as wetting and drying cycles are limited to the surface or to the material near the surface.

- very large failure, with weight loss from 100% to 80% (no samples);
- large failure, with weight loss from 80% to 60% (sample B2-12);
- medium failure, with weight loss from 60% to 40% (samples B2-10, 15);
- slight failure, with weight loss from 40% to 20% (samples B2-2, 5, 11, 13, 14, 21);
- very slight failure, with weight loss from 20% to 0% (samples B2-6, 7, 8, 9, 17, 18, 19, 20).

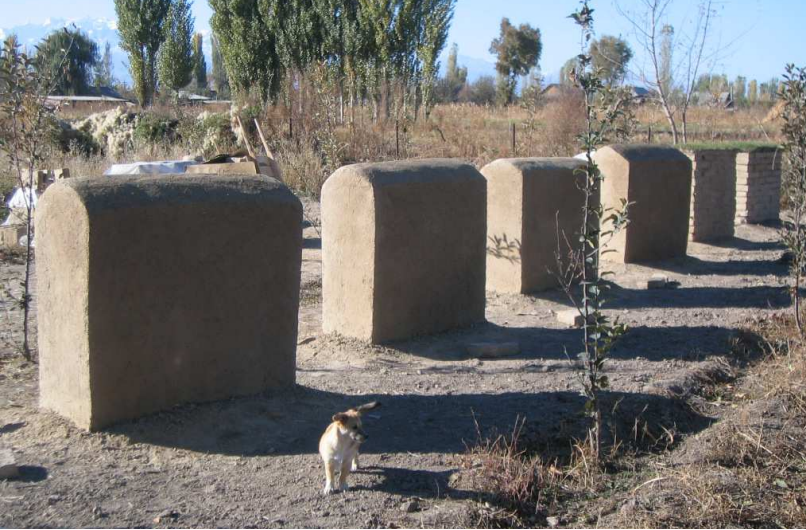
Fig. 20. The six test walls after construction. From right to left: TW1, TW2, TW3, TW4, TW5, and TW6

After completion of the test wall construction, both horizontal and vertical joints of TW 1 and TW 2 were pointed. The test walls to which plaster was applied were not pointed so as to allow proper keying of the coat to the fabric [27]. In September 2005, three new test walls were built in the project house yard (Fig. 21). The methodology employed for these followed that used for those constructed in October 2004 (as described in the previous section). The three test walls were provided with a permanent shelter structure made of timber and plastic sheets, so as to replicate conditions under a shelter structure. The main reason for this experimental work was to test the influence of the following decay mechanisms on three different plaster mixes: capillarity rise and soluble salts attack, erosion caused by wind-blown sand or silt, freeze-

In all cases the most serious erosion is found at the base of the wall. Capping of Test Walls 3-6 is behaving extremely well, whilst the turf capping of the first two walls failed due to lack of moisture. Coving is generally deeper on the south face of the wall and this is due to the fact that the rate of decay due to crystallization is influenced by directional exposure to the prevailing wind and sunshine. This is of course more noticeable in the elevations facing south and east, where the conditions for the salts to remain in solution change more rapidly. All test walls show the following general tendency: west elevations are behaving better than east elevations. The plaster of the upper parts of west elevations is still adhering and shows very little erosion. The plaster of the upper parts of east elevations shows deep erosional patterns. So far no major difference is noticed between the decay of south and north elevations: only at the footing level is the south elevation decaying faster.

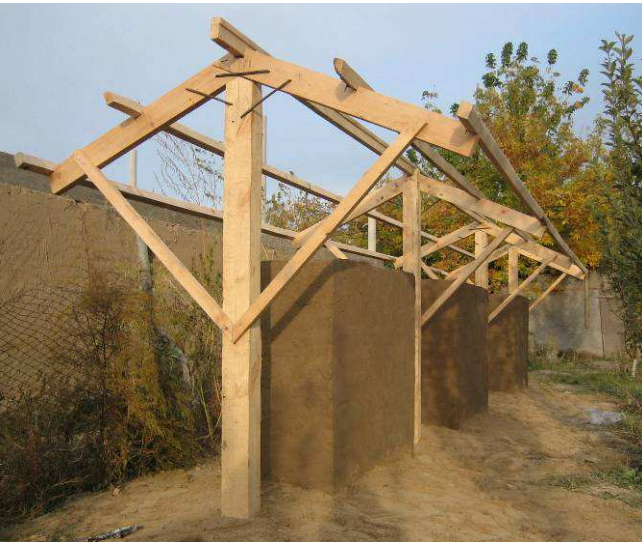
Fig. 21. Three walls were especially built for the testing of plaster under shelter structure condition (picture showing work in progress)

thaw cycles, wetting-drying cycles. The best-performing plaster will be employed for the conservation of the Buddhist temple II. The sheltered walls of the experiment are to help demonstrate the efficacy of the shelter, but also to select the most adequate plastering material for the shelter coat that will be rebuilt as part of the conservation programme. It should be noted here that assessment of the decay of the three sheltered walls cannot be reported here since their construction was undertaken one year later than the exposed test walls.
